MEMORANDUM

DATE:	June 13 th , 2016
FROM:	Eric Lancaster
SUBJECT:	Weekly Progress Report @ Gold King
TO:	Kerry Guy

Project: Gold King Interim Water Treatment Plant (IWTP)

Report No.: 24

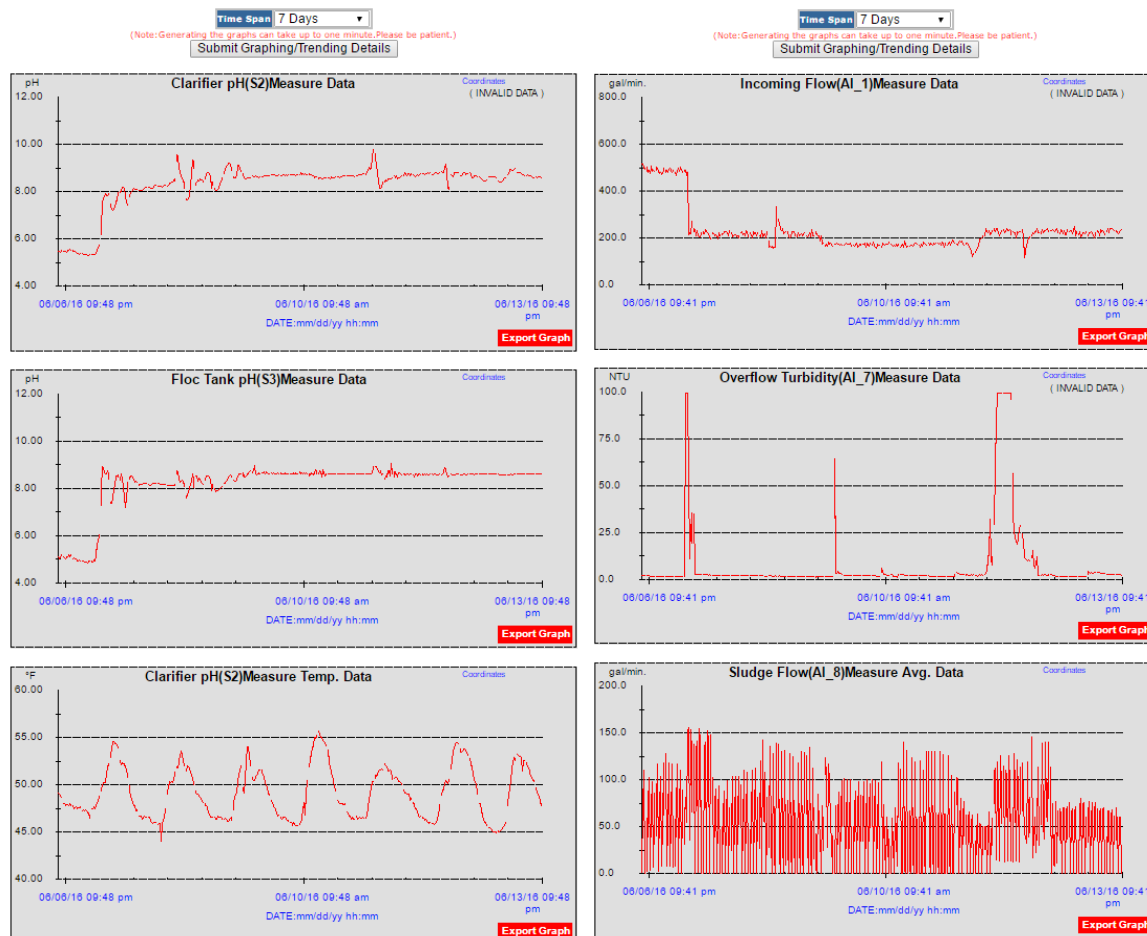
- The following graphs provide trending information during the previous 7 days. The dataloggers collect control information from the Lime Circuit (left) and Flow Circuit (right) Programmable Logic Controllers (PLCs) at the Gold King IWTP. Over the reporting period (6/6/16 – 6/13/16 inclusive) Alexco treated 4.77 million gallons at an average flow rate of 473 gpm with all discharged treated water leaving the 12" HDPE pipeline.

- Over the last few weeks, TSS levels coming into the IWTP have increased, causing occasional spikes at the discharge as measured by the turbidimeter and requiring higher flow rates to the bags and occasional flushing of the clarifier. This can be seen on the Overflow Turbidimeter readings for 6/7 and 6/12.

- Since early May, lime consumption has drastically increased. Lower pH levels coming into the IWTP were confirmed on 6/8 when Alexco measured the pH coming into Pond 1 at 1.8. Soon after, Alexco installed a third peristaltic pump at the lime slurry tank to support the additional requirement of lime slurry at the Reactor Tank.

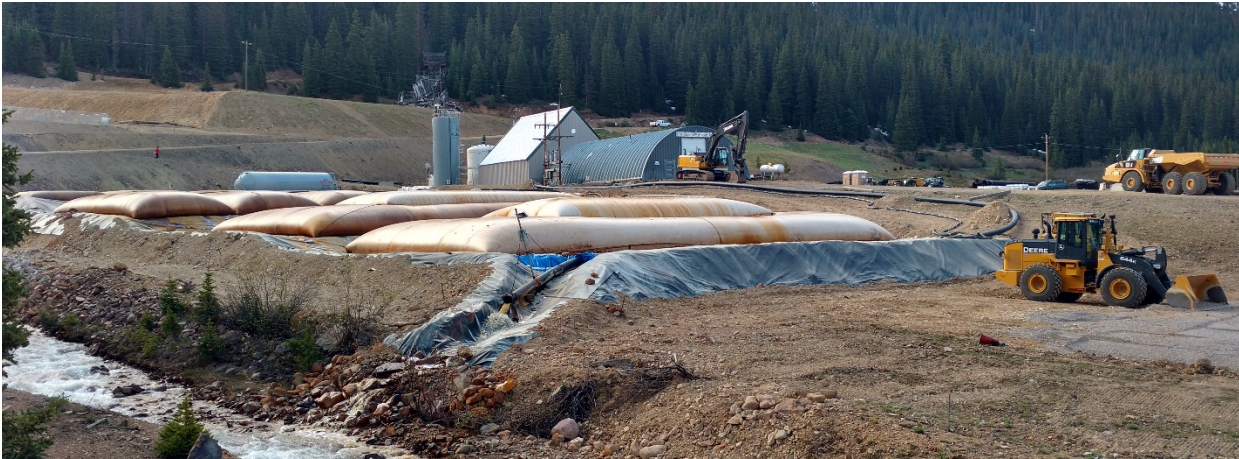
Photo 1: Bag in Cells C and D were stacked – Taken on 6/13/2016

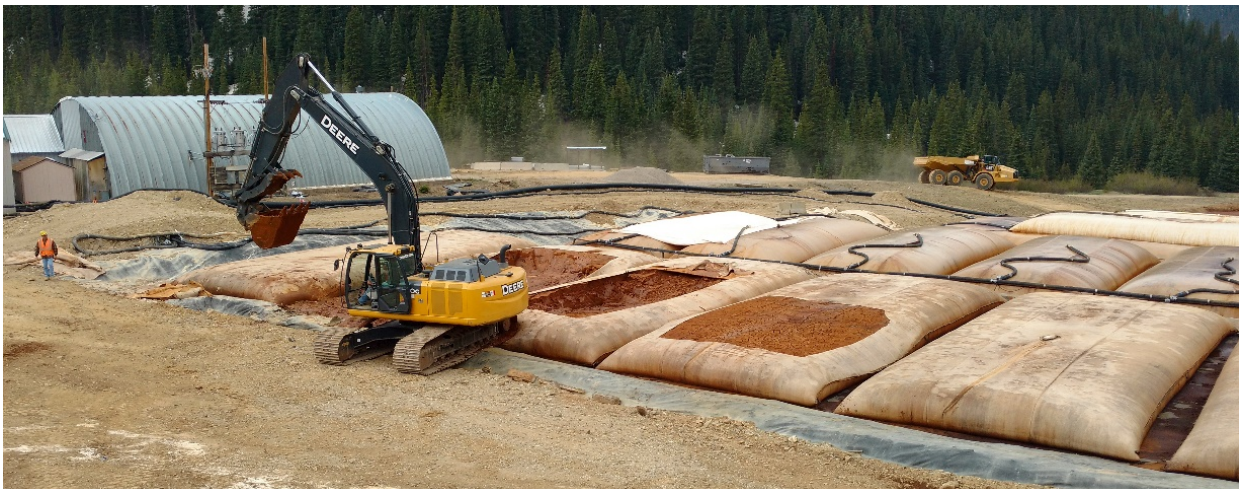
Photo 2: Removal of bags from Cell A – Taken on 6/13/2016

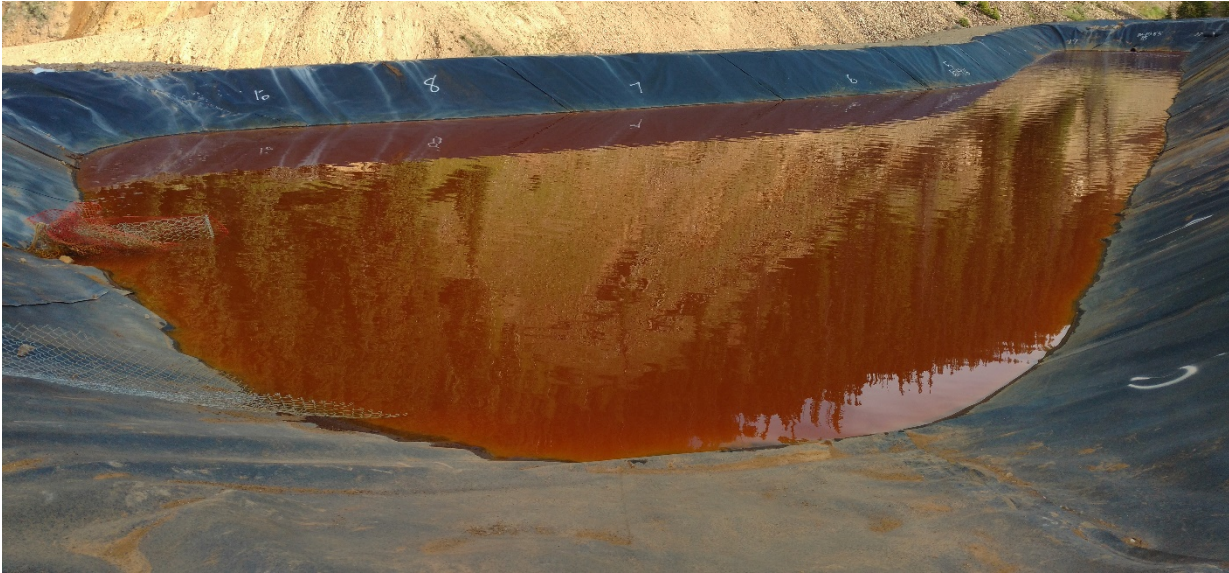
Photo 3: Pond 2 after sludge removal – Taken on 6/13/2016
